## Global MX-5 Cup Car Technical Service Bulletin #05-23-2017

### Optional: 2017 Global MX-5 Update: Front Sway bar mounting hardware

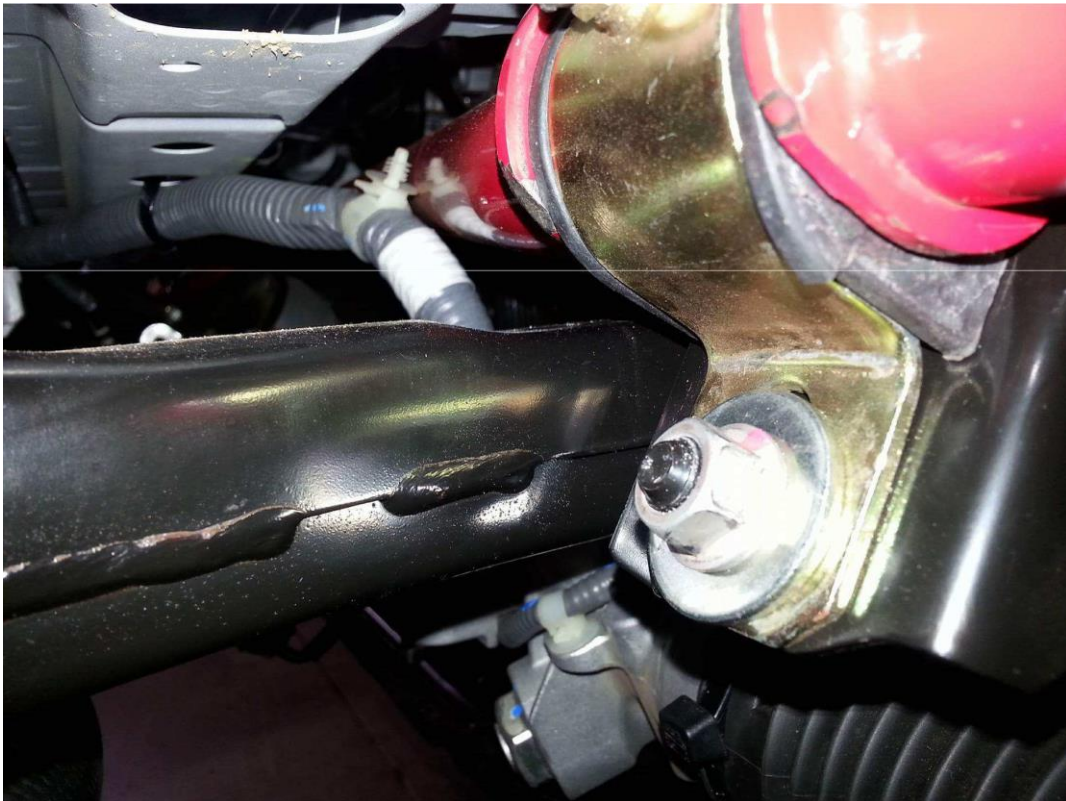
1. The front sway bar mounting bracket may become stressed or fatigued, you have the option of using a larger diameter washer (see picture below).

1. Remove and replace front sway bar nut and washer, replace with a larger diameter washer. Use thread sealant and torque the nut to 15 – 18 foot pounds
