## Global MX-5 Cup Car Technical Service Bulletin #05-23-2018B

### Optional: Global MX-5 Update: Starter power lead

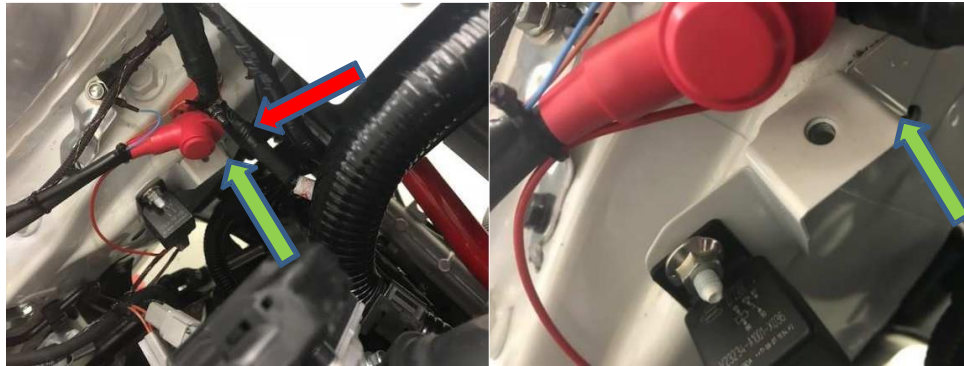
1. The main 12V power lead for the starter should be checked for chafing to ground.

1. Verify and correct with insulation, and or, re-clocking the starter hot wire (red arrow below) that the starter wire does not contact the chassis bracket (green arrow).
