Mazda MX-5 Cup Car Technical Service Bulletin #2022-01-13 #E

Optional: Intake Cam Timing Adjuster Motor Seal Elimination.

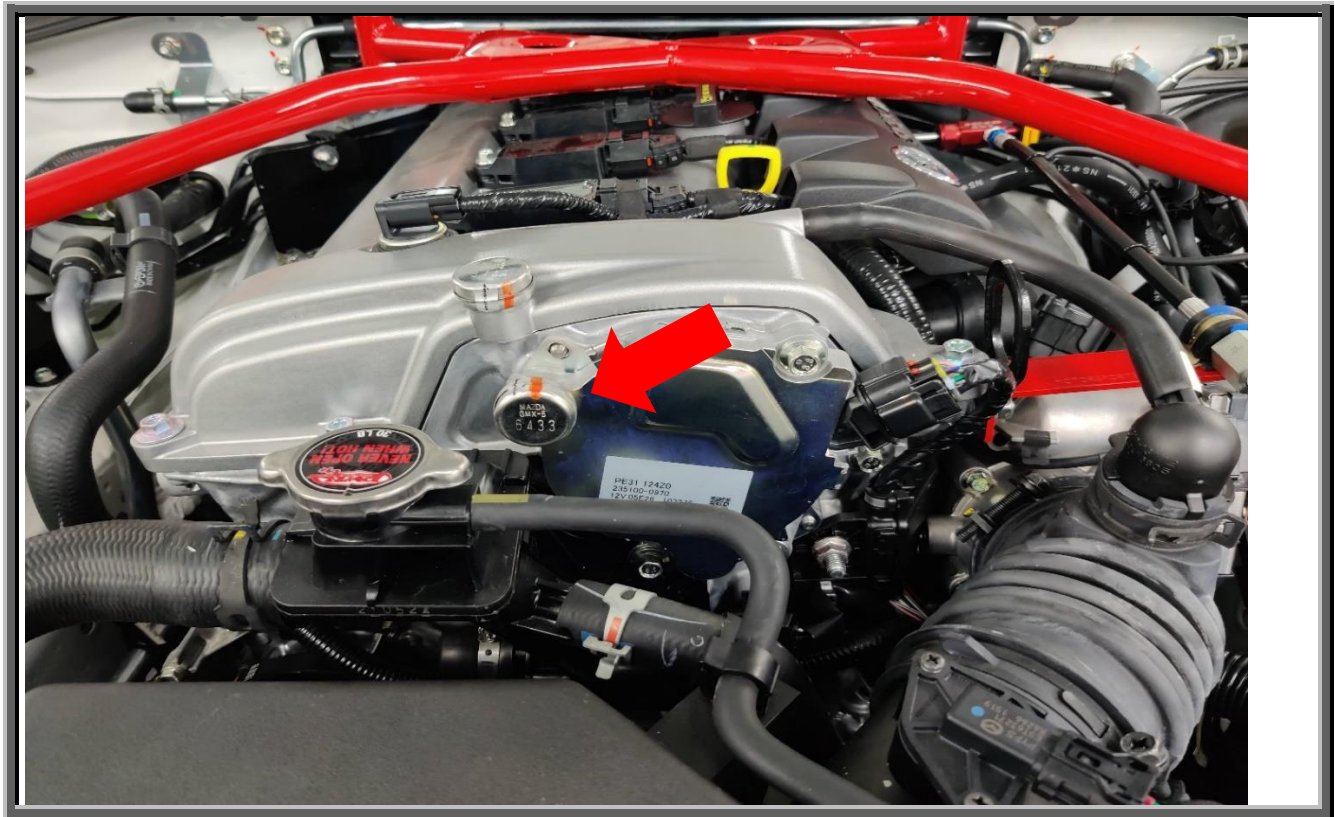
This TSB describes: Flis Performance has decided to eliminate the Mazda MX-5 VVT Actuator Motor P15B-12-4Z0 seal. This seal has no performance advantages and is a detriment to teams that might need to reset the VVT Actuator Motor if the engine rotation spins backwards.

Before removing the P15B-12-4Z0 seal, Teams must contact Flis Performance for approval, the VVT reset procedure and seal removal instructions.

Additional diagnostics may be required. This VVT reset procedure is not a guarantee to regain full engine performance.
